AIRESEARCH MFG CO OF ARIZONA PHOENIX  
RELIABILITY DATA FOR FLUIDIC SYSTEMS.(U)

4. TITLE (and Subtitle) RELIABILITY DATA FOR FLUIDIC SYSTEMS	5. TYPE OF REPORT & PERIOD COVERED Final Engineering Report 11 Apr 72-30 Jun 76	6. PERFORMING ORG. REPORT NUMBER 76-411479

7. AUTHOR(s) Wallis T. Fleming Harry R. Gamble	8. CONTRACT OR GRANT NUMBER(s) DAAG39-72-C-0092	
9. PERFORMING ORGANIZATION NAME AND ADDRESS AiResearch Manufacturing Company of Ariz. A Division of The Garrett Corporation Phoenix, Arizona	10. PROGRAM ELEMENT, PROJECT, TASK AREA & WORK UNIT NUMBERS Program element: 6.21.14.A

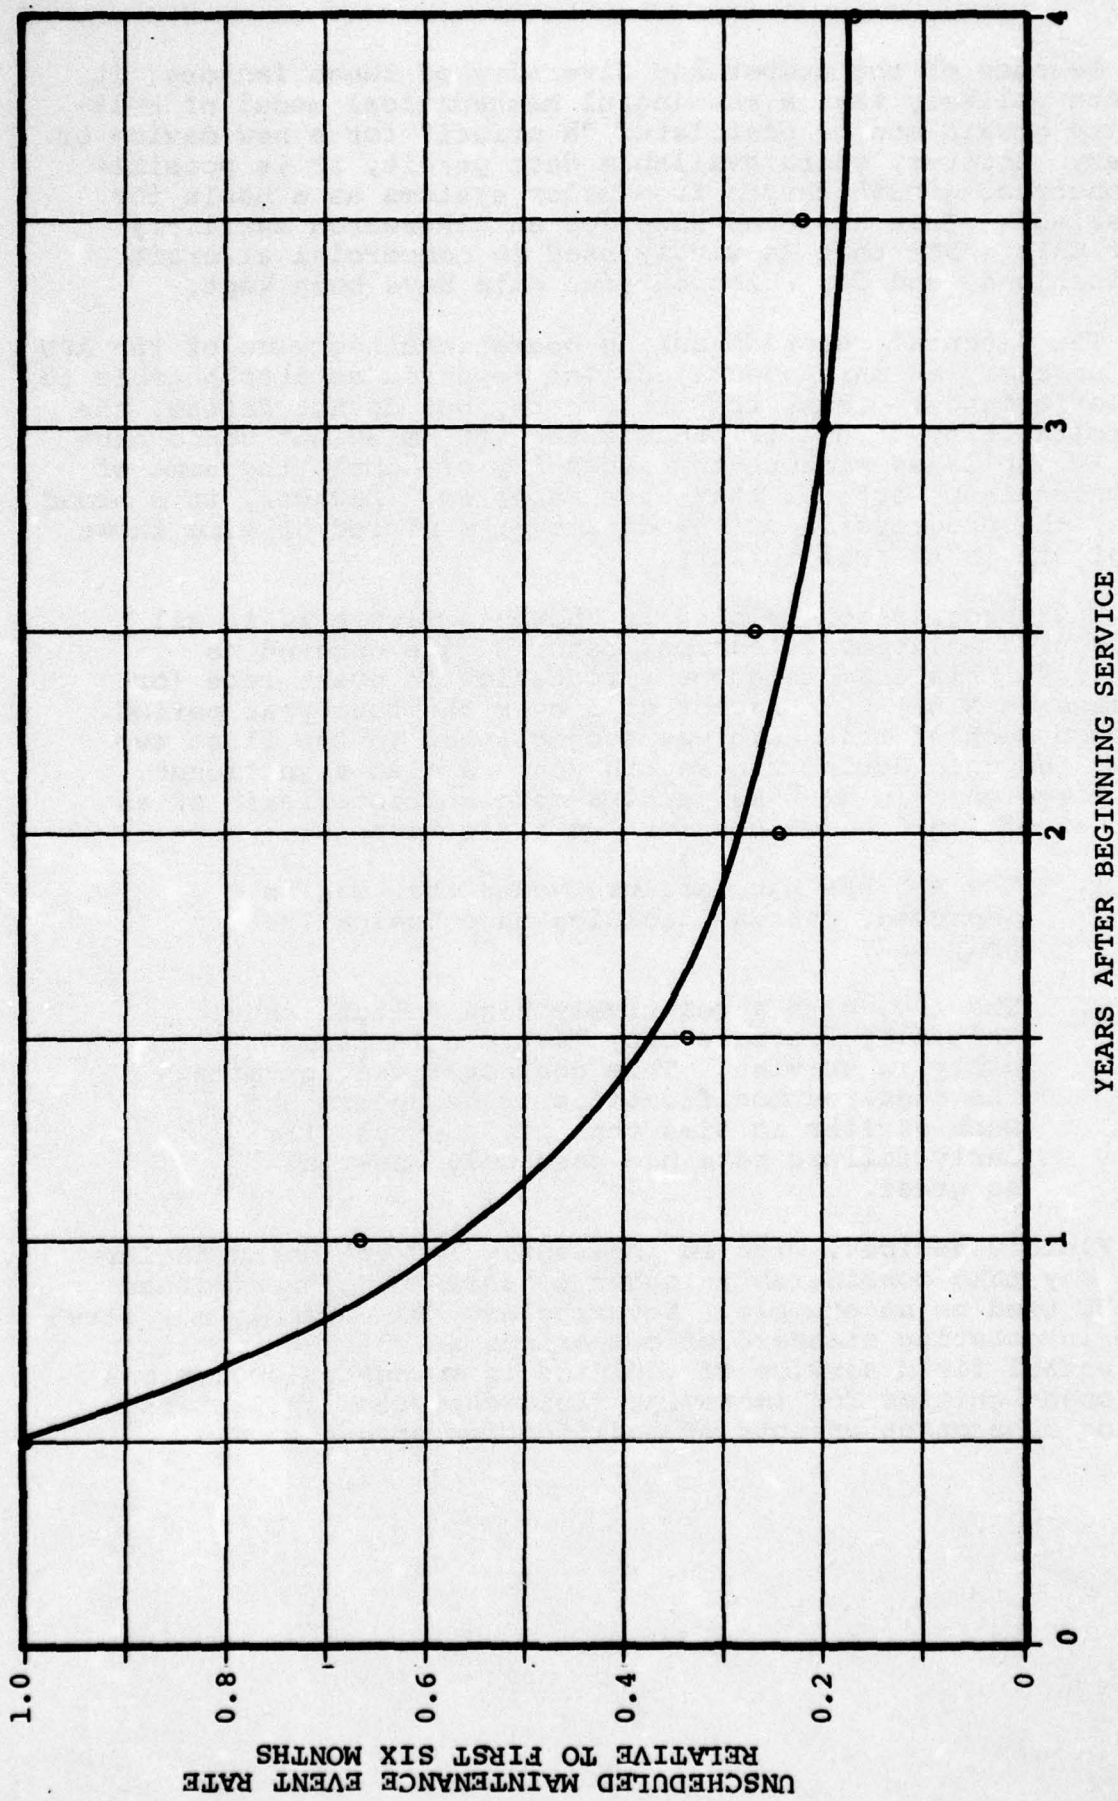
Figure 1. Growth in APU Reliability.

1. The APU has many failure modes that can be improved, whereas fluidics have basically only one.
2. The APU, with a relatively high failure rate initially, reveals many "pattern failures" early in service. This characteristic permits the required modifications to be determined much earlier in time than if, perhaps, its early failure rate had been only one-tenth as great.

Fluidic devices, with an inherently low beginning failure rate, may take considerably longer to show improvements than the APU used as an example. Nevertheless, the example may serve as an interesting standard of comparison as the data obtained from actual field service of fluidics in aerospace operations show opportunities for improving fluidic systems reliability and the consequent effects of modification programs.

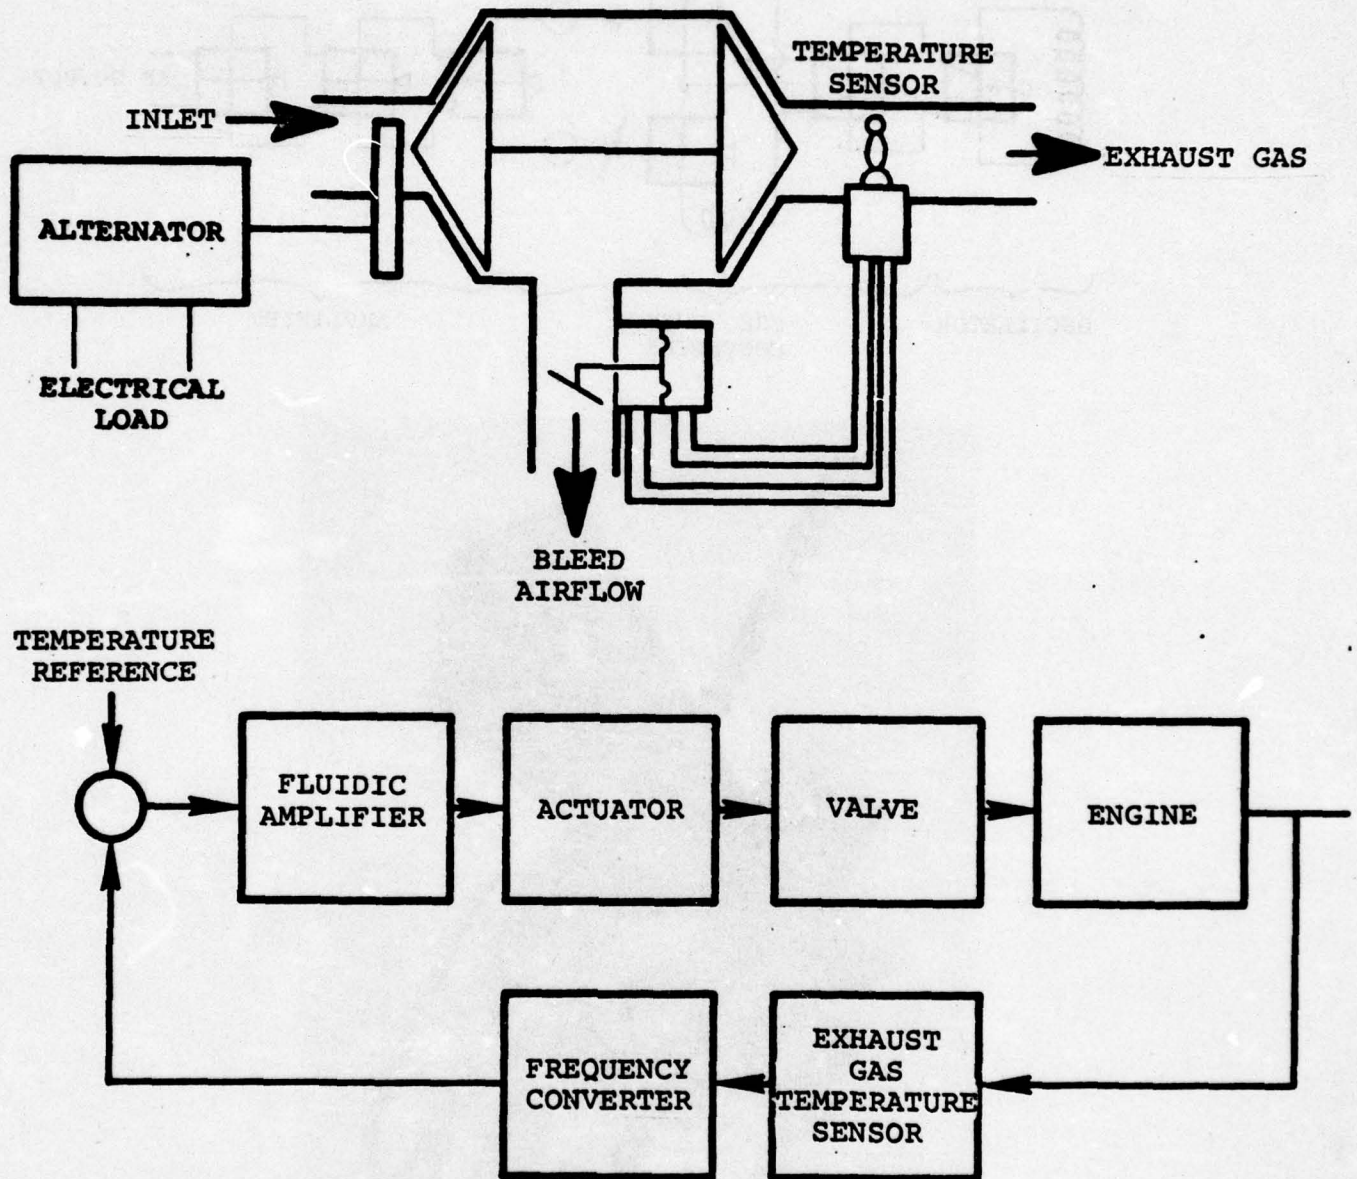
Figure 2. Load Control System Block Diagram.

For these experiments, the normal temperature sensor and control functions were replaced by a fluidic temperature-sensitive oscillator, frequency converter, and gain block. Except for the DC-9 installation, supply pressure was obtained from the compressor plenum via a 150-micron wash-by filter and a 25-micron absolute inline filter. A conventional pressure regulator controlled the supply pressure to  $20 \pm 1.5$  psig over the operating range of the control. Figure 2 block diagrams the complete load control system.

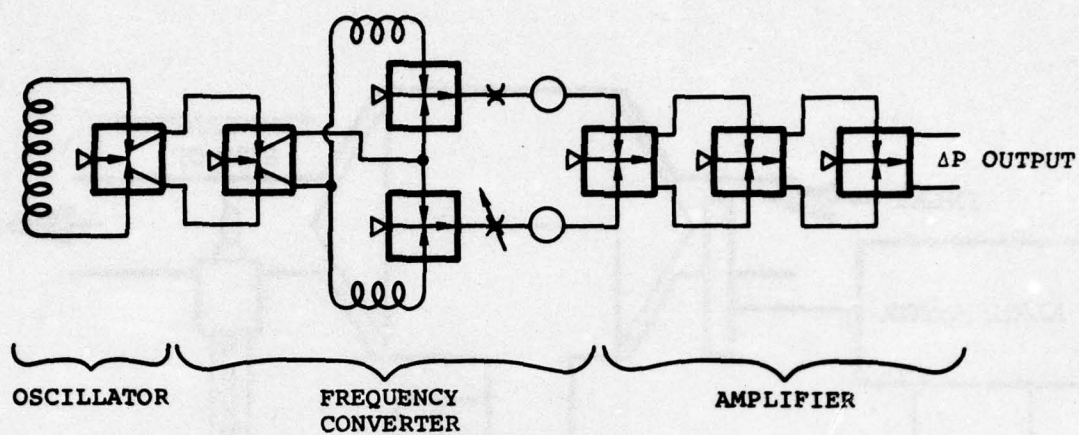
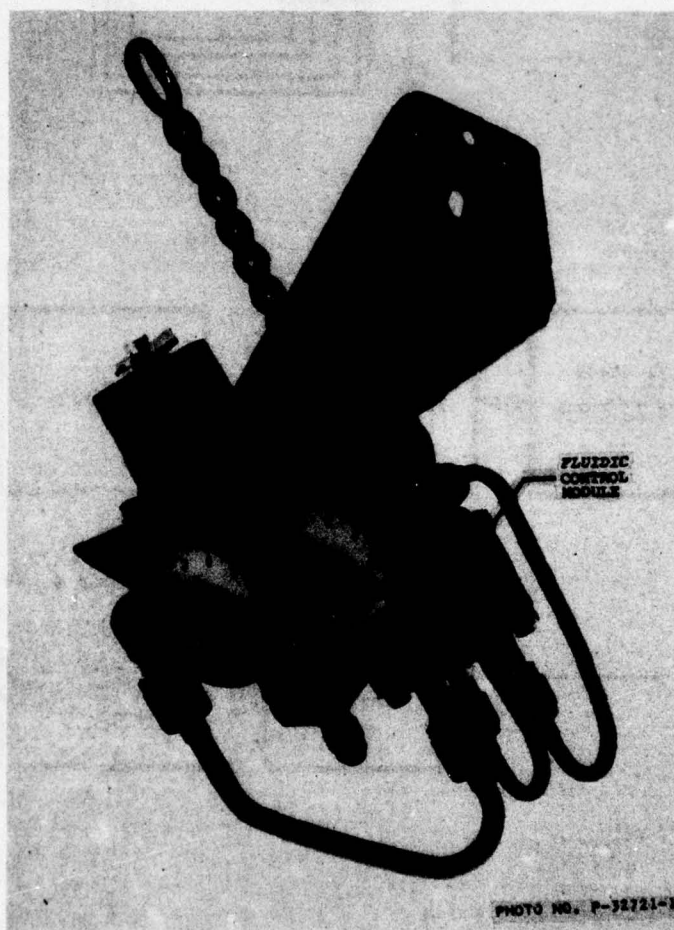
Figure 3. Schematic Diagram and Pictorial View of Fluidic Temperature Sensor.

Although previous laboratory engine tests of this type of sensor had been successful, the first field test of this particular sensor was not in an engine. A sensor was built into a package, also shown in Figure 3, and installed on a Delta DC-9 aircraft so that it operated from the environmental control system main supply duct air. The pressure gauges were checked periodically to detect any failure.

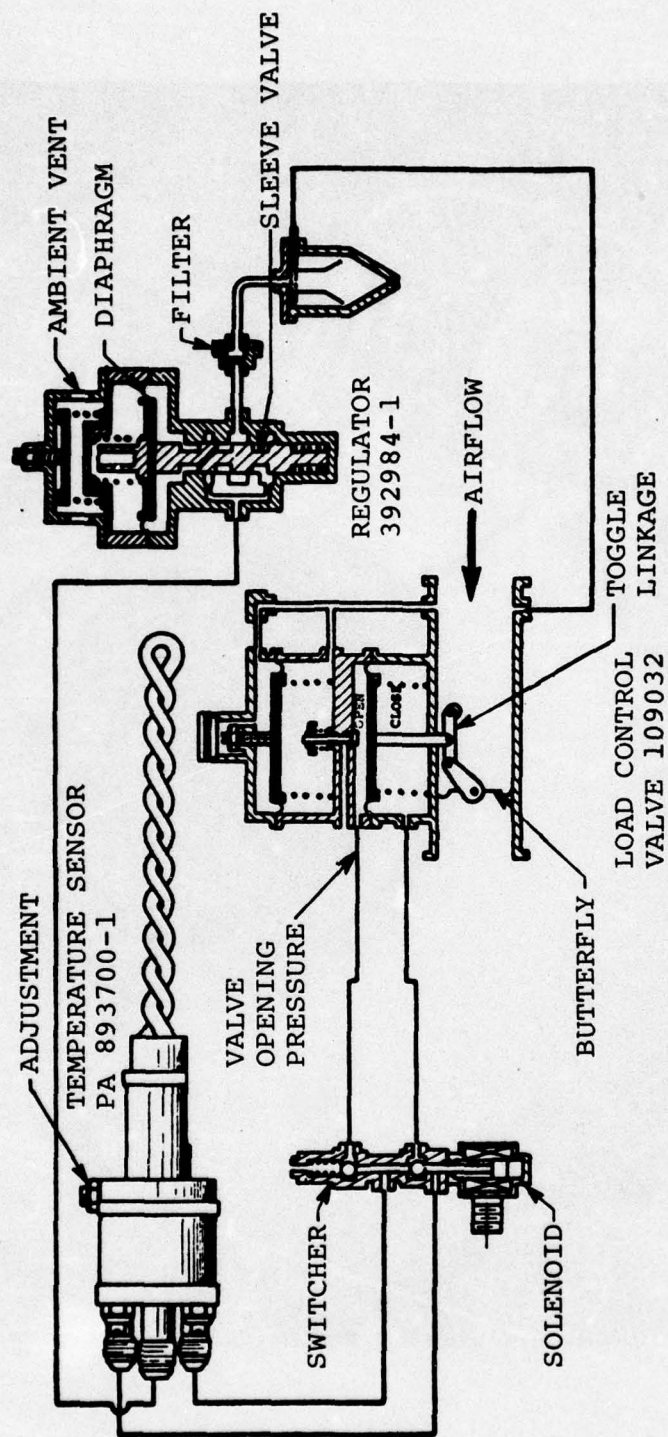
Figure 4. Fluidic T<sub>5</sub> Sensor and Load Valve System.

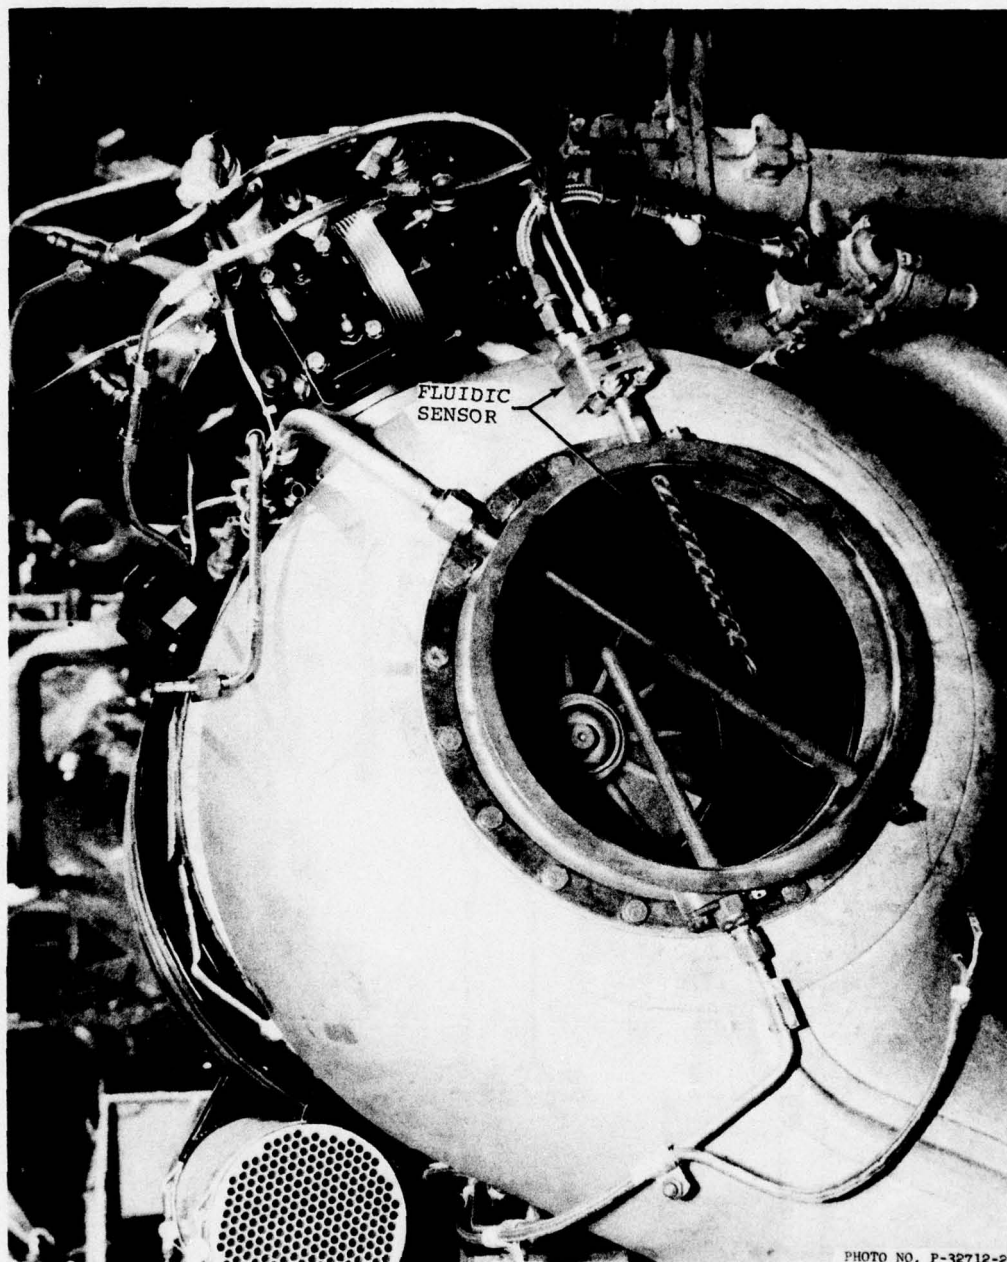
PHOTO NO. P-32712-2

Figure 5. Fluidic Temperature Sensor Installation on an AiResearch 95-2 APU.

As previously described for ground cart APU's, the APU's installed on aircraft also require exhaust gas temperature monitoring to protect against inadvertent overloading during engine starting. The fluidic temperature sensor and control circuit previously described was used to replace the normal pneumatic bleed sensor and control valve. The fluidic control module contained an adjustment screw for valve closure set point. Instrumentation was provided to detect a system malfunction.

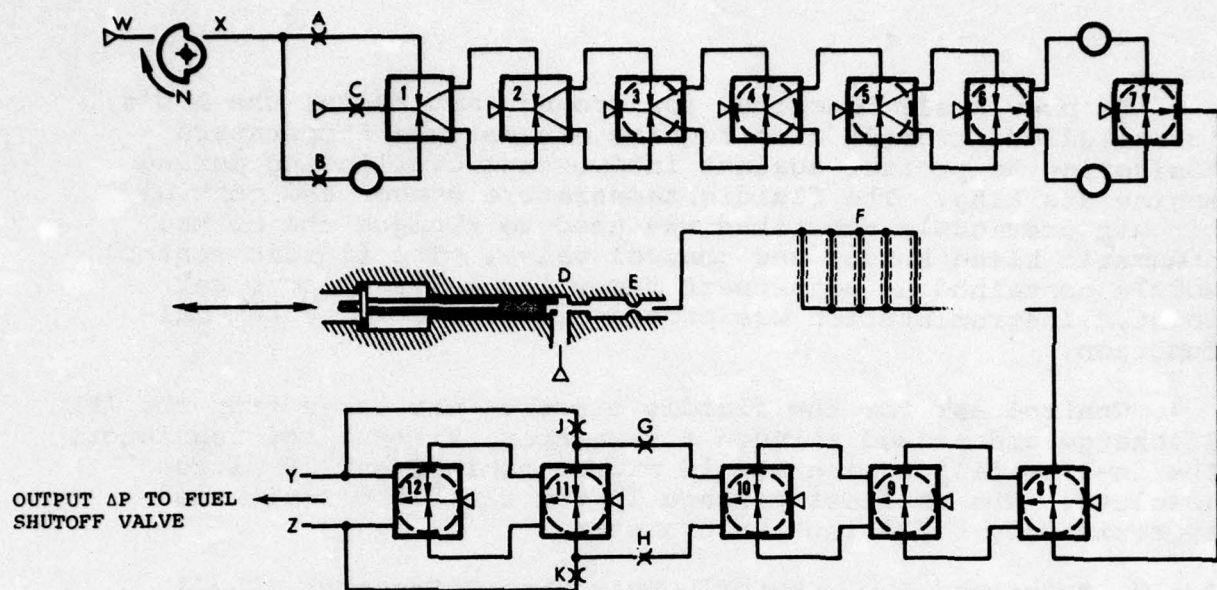
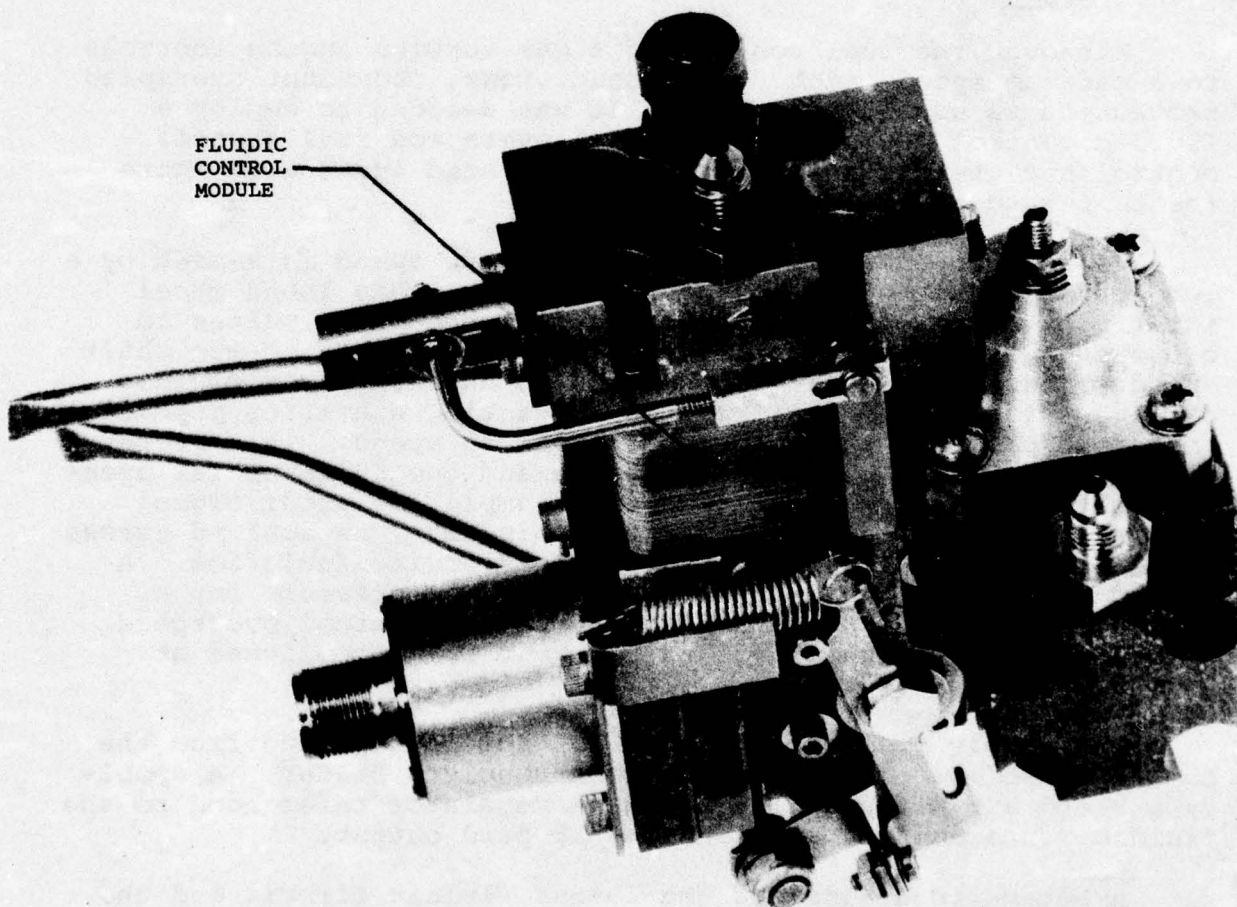
PHOTO NO. P-40832

Figure 6. Fluidic Block Diagram and Pictorial View of Overspeed Fuel Shutoff Valve on AiResearch TSE231 Engine.

A schematic diagram of the latest fluidic circuit and the complete fuel shutoff valve are shown in Figure 6.

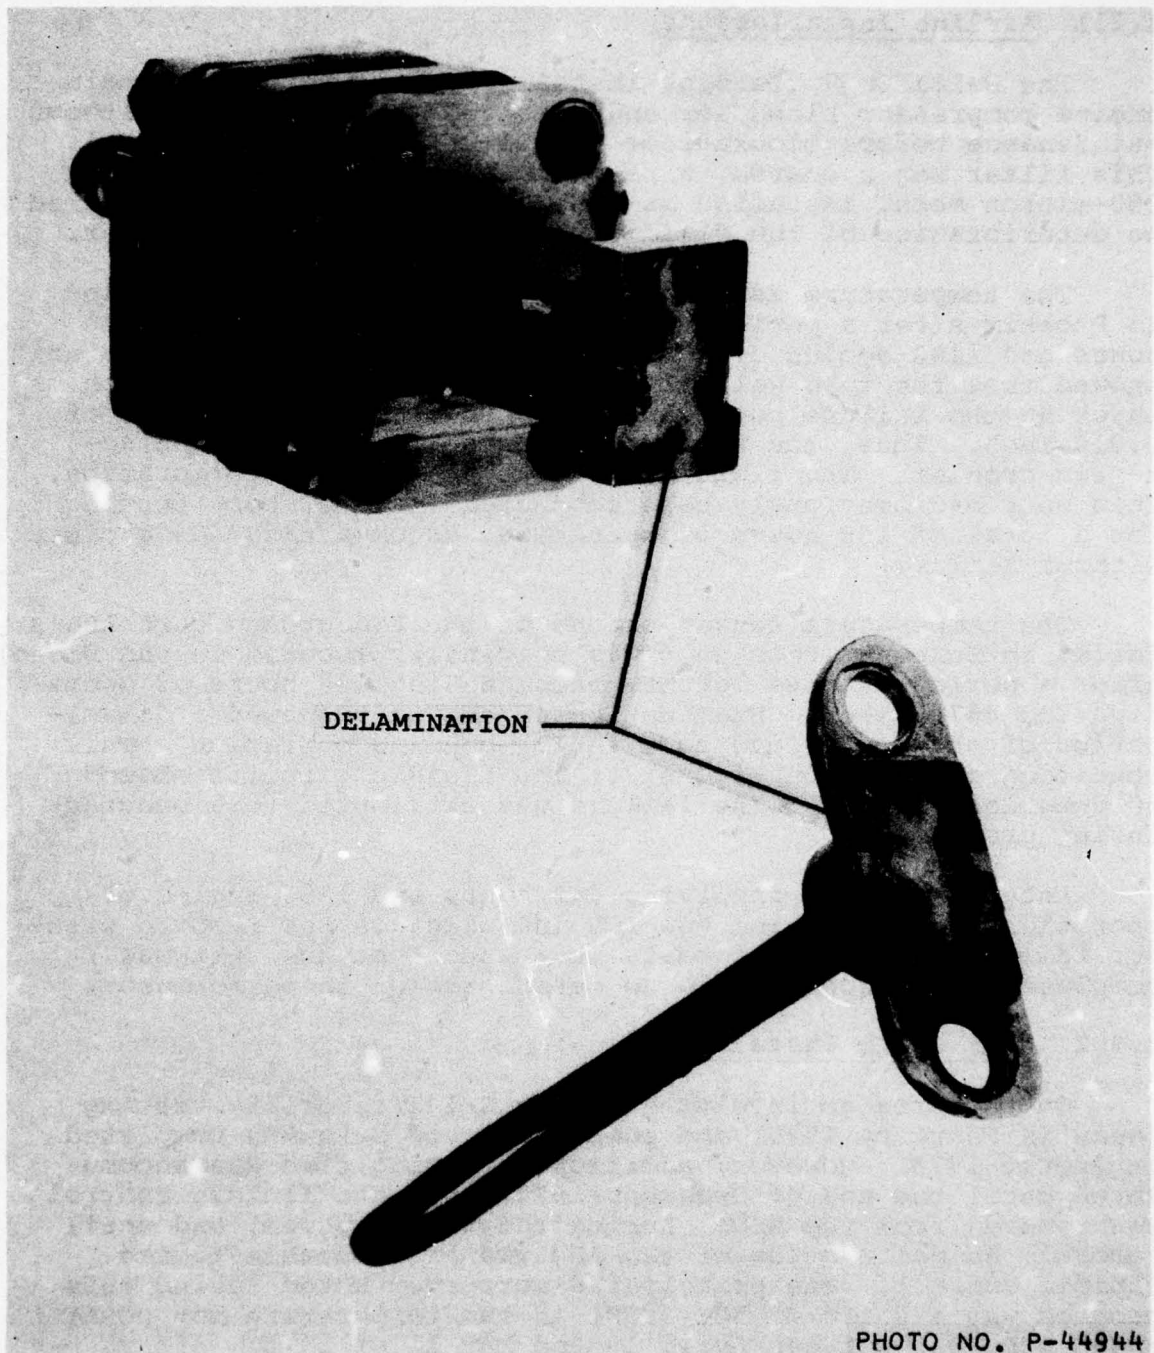
Figure 7. Bonding Delamination Failure of Temperature Sensor.

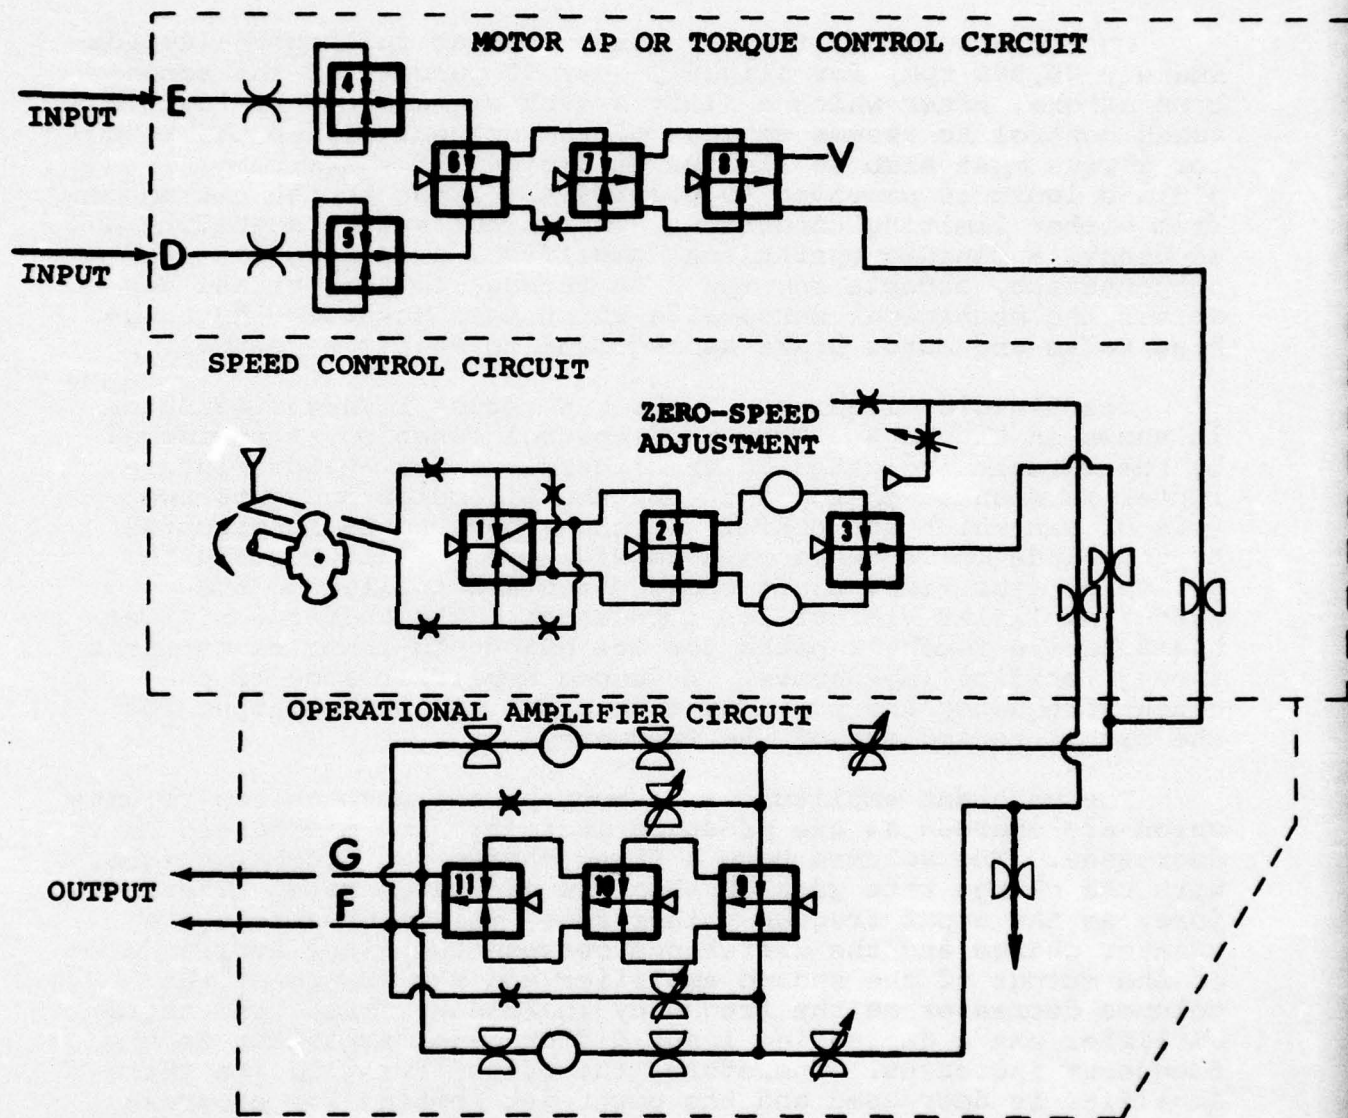
Figure 8. Schematic Diagram of Fluidic Control System on CF6 Thrust Reverser Actuator

The fluidic circuitry of the CF6 thrust reverser actuator is shown in Figure 8. The speed control function is performed by the circuit indicated on the figure. A four-bladed interrupter is mounted on the shaft of the air motor and cuts two jets of air which are positioned such that one is interrupted by the blade while the second is wide open. This results in pulses at four times shaft speed which are applied to the buffer amplifier via orifice impedances. The buffer amplifier has positive feedback paths for its output-to-input connections through orifice impedances. A second amplifier accepts the output frequency and provides a constant amplitude output for the signal regardless of the frequency.

The constant amplitude frequency passes through two volumes which are charged as the pressure increases and discharged as it decreases. The volumes have a fixed charge and discharge rate, with the charge rate greater than the discharge rate. Therefore, as the input frequency increases, the volumes retain a greater charge and the difference between the fixed amplitude of the output of the second amplifier and the charge of the volumes decreases as the frequency increases. Thus, the third amplifier has a decreasing input differential amplitude as the frequency increases. Therefore, the output swing of the third amplifier is decreased and the power jet remains for progressively greater lengths of time over the output channel. The output is therefore an increasing pressure with increasing input frequency. This output signal is applied to a summing junction where the motor torque override signal is added.

This torque signal is derived from the motor  $\Delta P$  which is sensed in the motor differential pressure or torque control circuit at input Ports E and D on the schematic diagram of Figure 8. The orifices shown are of the vortex type and consist of six chambers in each path. Amplifiers 4 and 5 are used for impedance matching and Amplifiers 6, 7, and 8 scale the signal to the desired value for addition with the speed signal.

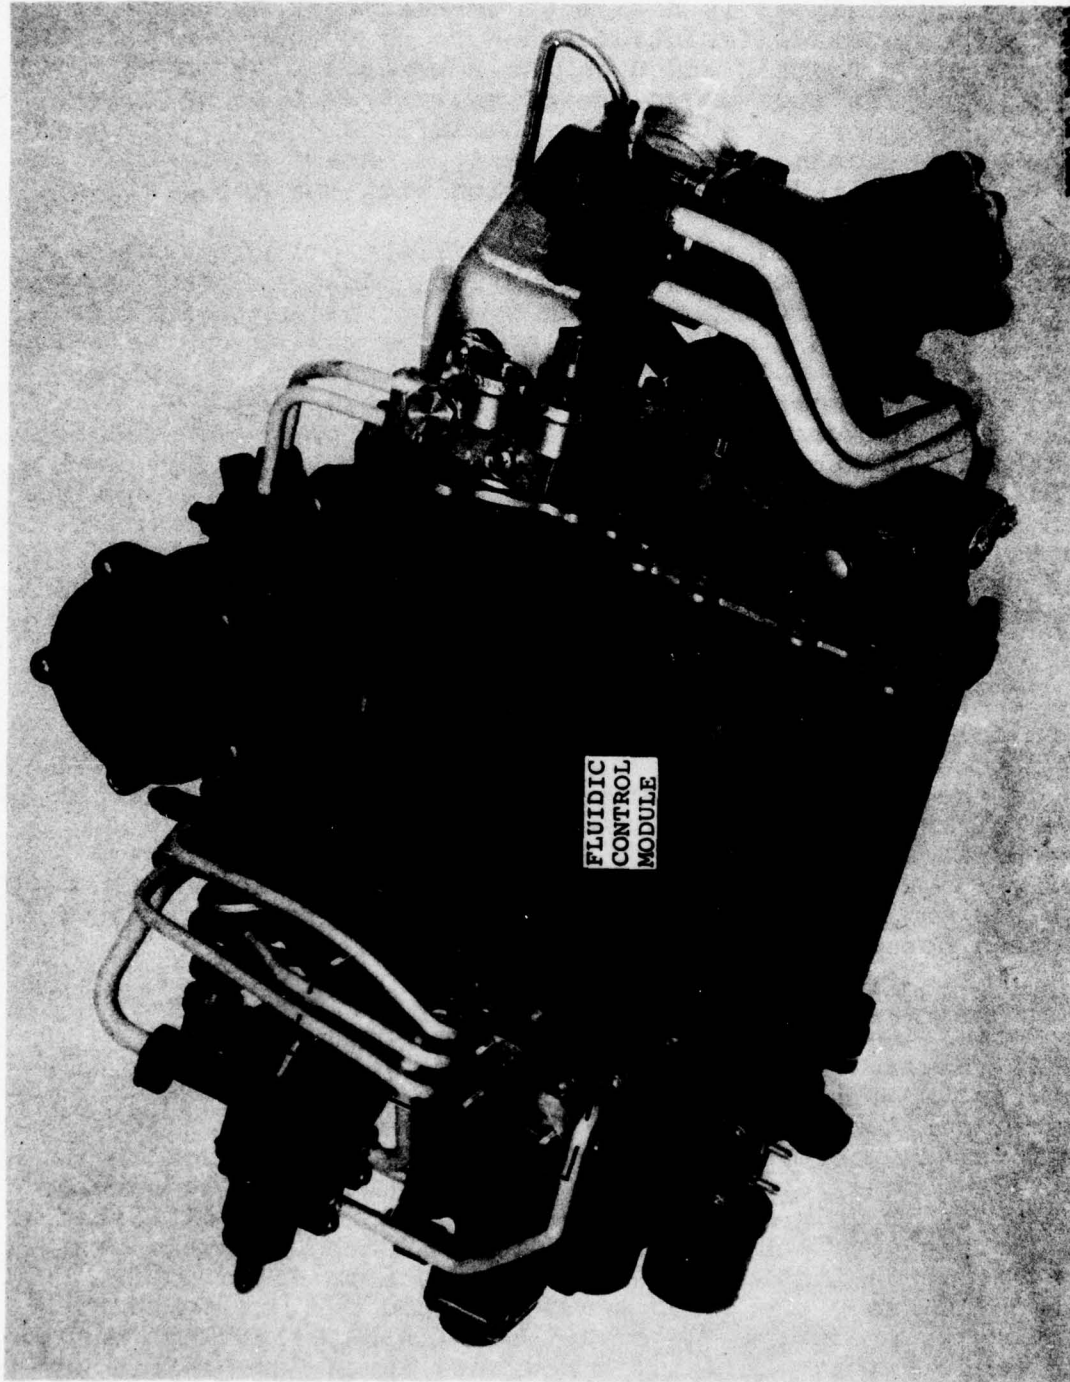
Figure 9. Pneumatic Actuator for Thrust Reverser on General Electric CF6 Engine (AiResearch Part 126366-1-1).

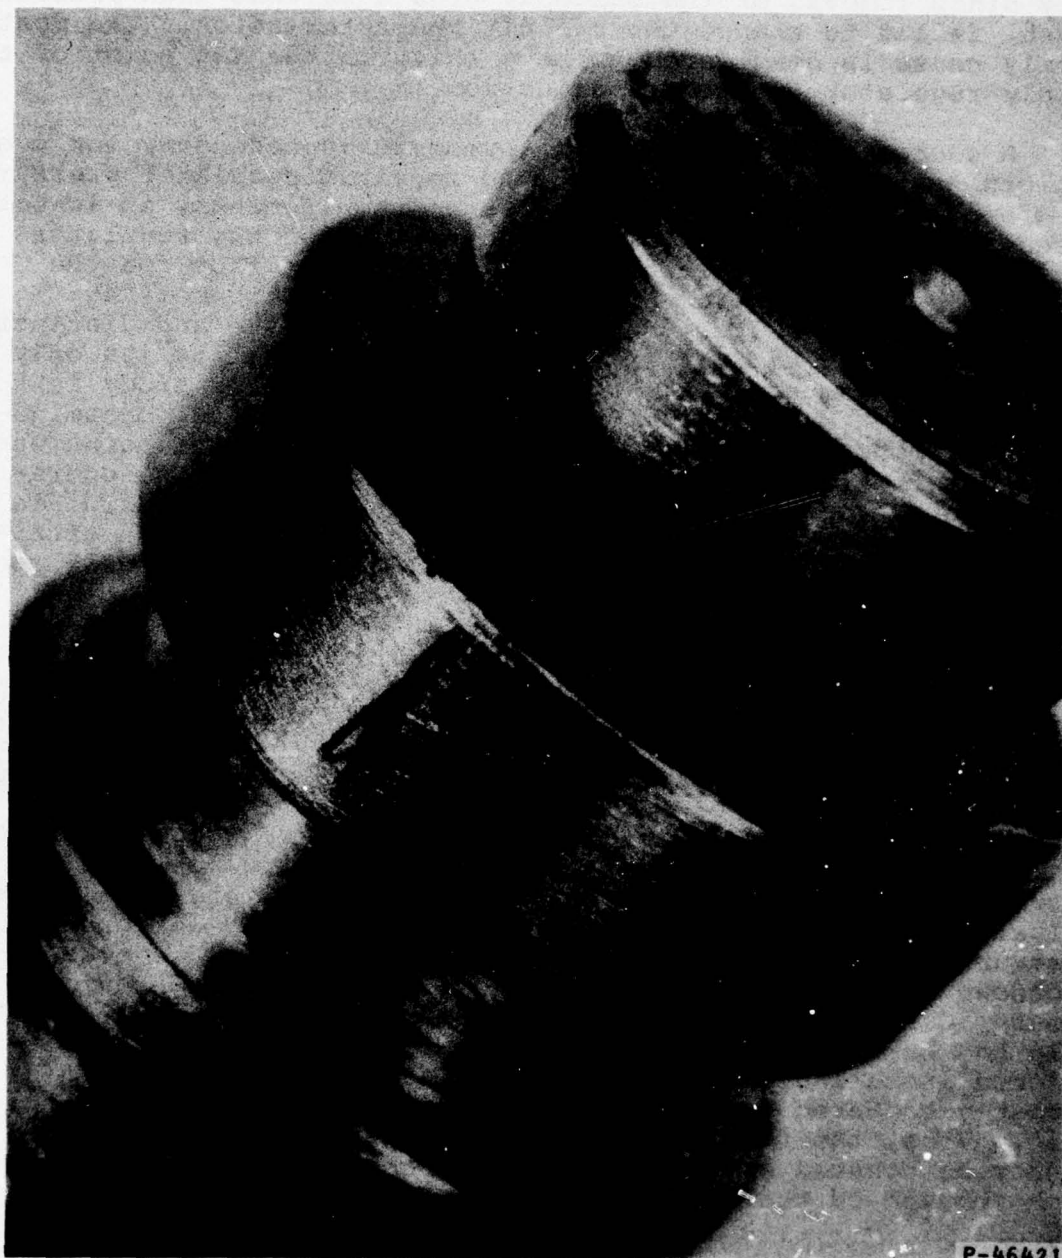
P-46421

5.1.2.5 Fluidic Control Module Serial 439 - The complete actuator (Pneumatic Actuator Serial AEX-10233) was removed from a National Airlines DC-10 as inoperative in the low-speed mode. Disassembly of the unit revealed a small aluminum chip lodged between the poppet and seat of the differential pressure relief valve. This valve creates a bias pressure in the differential pressure control circuit. The effect of this failure mode is shutdown of the actuator so that low-speed operation cannot occur. Careful examination of the components revealed that the chip had been shaved from the relief valve inlet port by misaligned installation of the steel inlet pressure line. This probably occurred during a previous field modification of the unit. Thus, the failure was attributed to mishandling, and cannot be counted as a verified failure of the fluidic circuit. A photograph of the chip is shown in Figure 10.

Figure 10. Aluminum Chip in Differential Pressure Relief Valve Removed From Actuator Assembly 126366, Serial AEX-10233, Thrust Reverser on General Electric CF6 Engine.

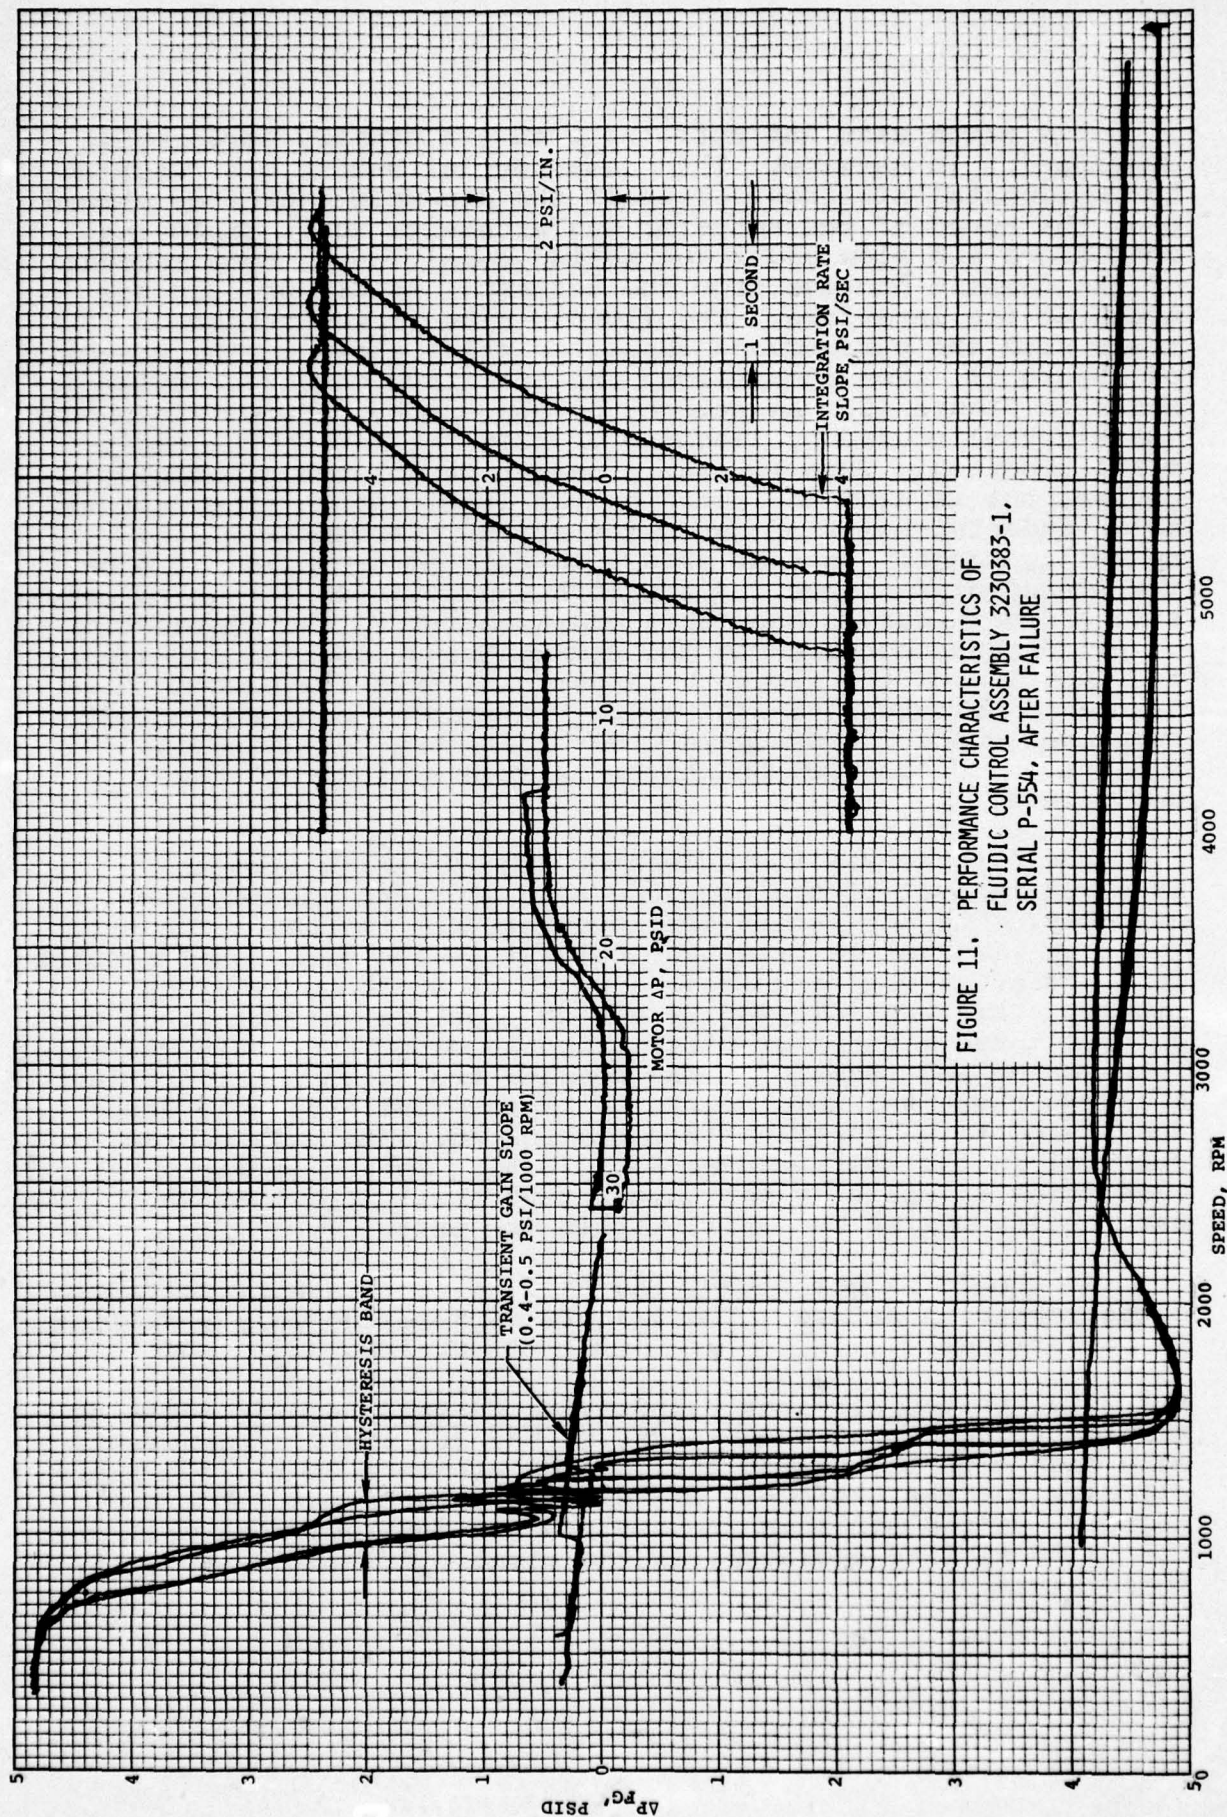
FIGURE 11. PERFORMANCE CHARACTERISTICS OF  
FLUIDIC CONTROL ASSEMBLY 3230383-1,  
SERIAL P-554, AFTER FAILURE

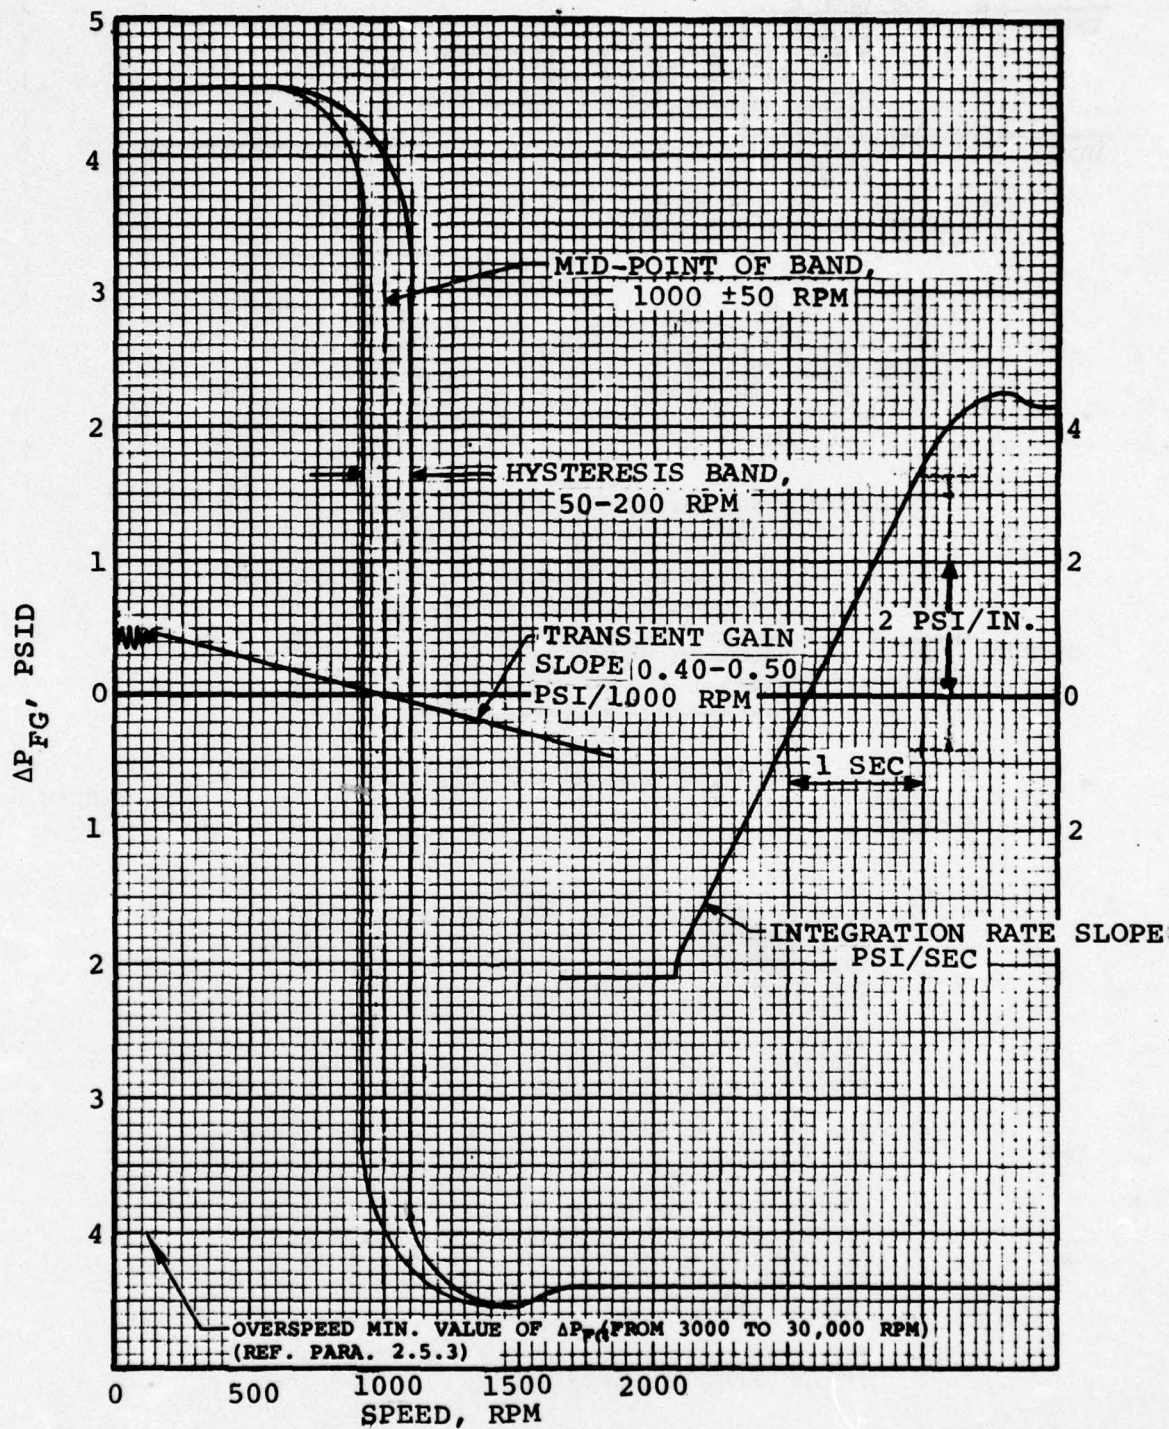
Figure 12. Specified Performance Limits for Part 3230383-1.

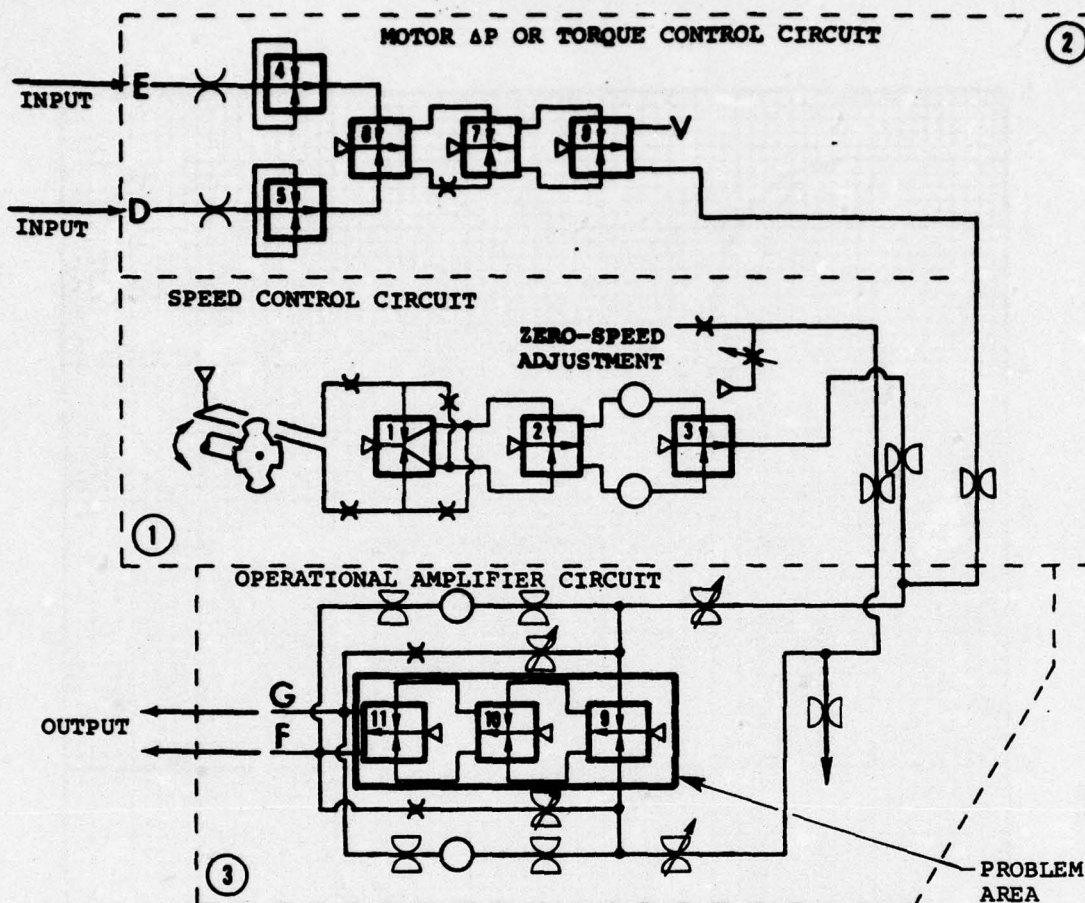
- ① A PULSE GENERATOR OF THE JET INTERRUPTER TYPE PROVIDES A PULSE FREQUENCY AT 4 TIMES SHAFT SPEED. THIS FREQUENCY IS USED AS THE INPUT TO A FREQUENCY-TO-PRESSURE CONVERTER CONSISTING OF A BUFFER AMPLIFIER, DISCRIMINATION, RECTIFICATION AND FILTER CIRCUITS. THE OUTPUT IS A DIFFERENTIAL PRESSURE PROPORTIONAL TO MOTOR RPM.
- ② THE ΔP SENSOR ACCEPTS INPUTS FROM THE INLET AND OUTLET OF THE GEAR MOTOR TO GENERATE A SIGNAL TO OVERRIDE THE LOW-SPEED CONVERTER SIGNAL WHEN THE MOTOR IS STATIONARY. THIS LIMITS THE TORQUE OUTPUT OF THE MOTOR TO PROVIDE THE NECESSARY LOADING OF THRUST REVERSER INTO THE AIRCRAFT STRUCTURE WITHOUT CAUSING DAMAGE.
- ③ THE COMPENSATION AND OUTPUT CIRCUITS PROVIDE SYSTEM DYNAMIC COMPENSATION.

Figure 13. CF6 Fluidic Control System Schematic Showing Problem Area in Part 3230383-1, Serial P-554
